The Analysis of the Causes of Cartridge Igniter in Industrial Boiler Water Cooling Wall

Abstract—In accordance with the large area cartridge igniter of the heating boiler, through the analysis of the vapor sample in the running, and the analysis of the scale components and the metallography of the model test sample of cartridge igniter, the causes of the boiler cartridge igniter from chemistry and the metallography study of the material are discussed, and put forward the effective processing methods.

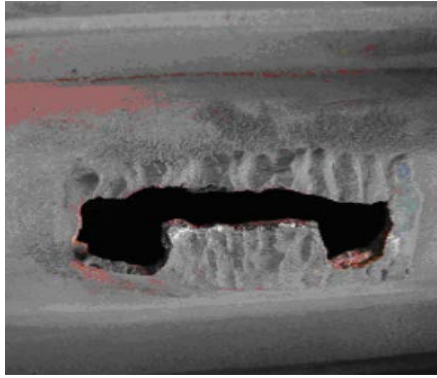
Choosing to research the two representative test samples of the disabled samples: A: It crazes through the pipe lengthways and takes on window state near the seam of the water cooling wall. The maximal hatch degree of the lengthways and transverse are 102.36mm and 22.52mm. There is no obviously plastic distortion near the piping, which edge coarseness and fracture brittleness, and there is a clearly reduction of the pipe wall. The picture 1 is the appearance of the sample and the inner surface state is according to the picture 2. B: There is also no obviously plastic distortion near the piping, it crazes through the pipe length ways or transverse that takes on flaw state near the elbow. Within the sample piping elliptic eroded offspring which extrusive inner face and relax texture is in existence. There are many pits on the pipe surface which the distinct phenomenon such as eroded diminution and scale eroded are in existence seems utensil state after wiping off the eroded offspring. The picture 3 is the appearance of the sample, the state of the nearly piping inner surface is as picture 4 showed and the configurations of the metallic floor pipe sample after mechanical elimination the eroded offspring are regarded as picture 5.

Figure 1. The appearance of window state samples

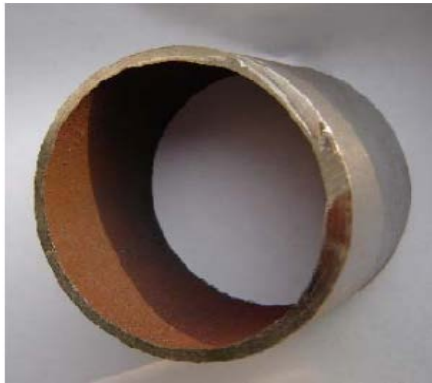
Figure 2. The inner surface of the nearby piping of window state samples

We can see the symmetrical and loosen folium of rufous deposit nearby the piping surface of A, and the sediment of the face-fire pipe wall is more than the back against, and we also can see the un-sizable pits which utensil state after scouring off the sediment. There are many dense heaves which diameter among 1-5mm nearby the piping surface of B. The face of heaves is rufous, and the hypo-face is black powder, Peeling part of the eroded sediment off is a kind of salt condensate. There are many different bulk discontinuous pits of utensil state after washing the eroded sediment off by acid. The elliptic eroded offspring which texture relaxed has a 3-23.65mm length and ply of 1-7mm, what is protrude the inner face of the samples near the piping in-wall, and the flaw is in the middle of the eroded pits. There are silvery white metal body, rufous eroded offspring, black Fe₃O₄ and white salt beds of small flaws in the bottom of the eroded pits by mechanical method eliminating the agglomerate eroded offspring, and the maximum depth of eroded pit is 3.1mm.

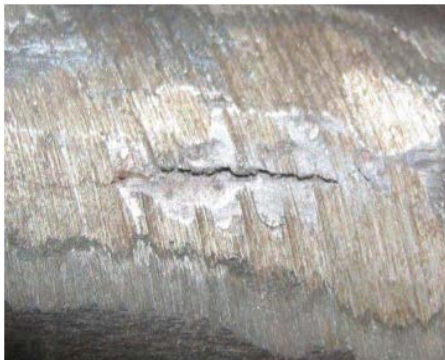
Figure 3. The appearance of flaw state samples

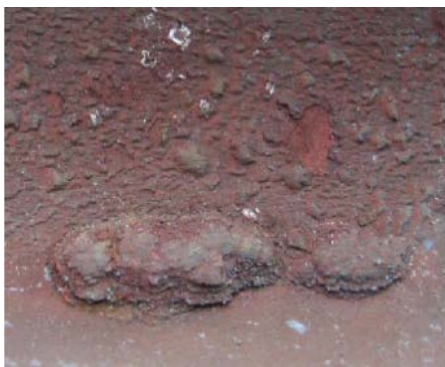
Figure 4. The inner surface of the nearby piping of flaw state samples

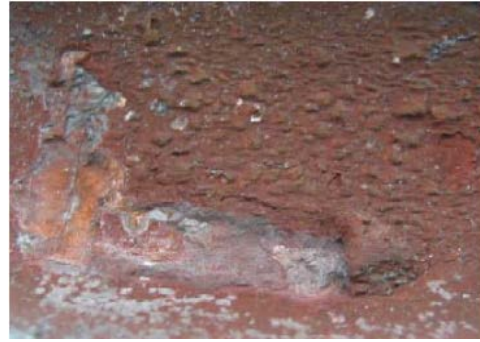
Figure 5. The configurations of the metallic floor pipe sample after mechanical elimination the eroded offspring

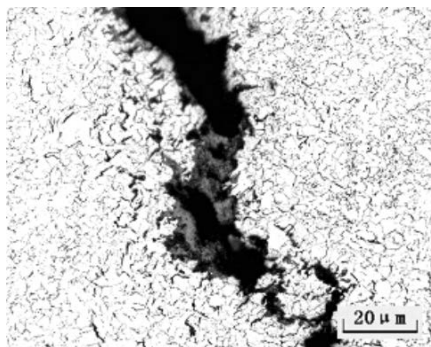
Picture 6 shows the metallography round sample A, the metallography of A are ferrite and farthing pearlite, we can see a mass of flaw which the pearlite nearby seriously decarburization through the crystal.

Figure 6. The metallography round sample A

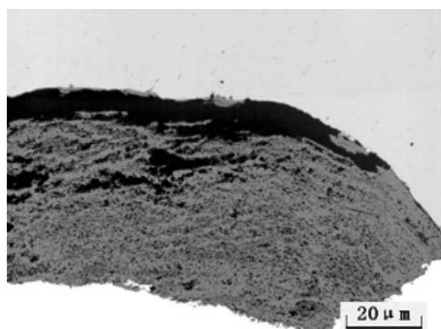
Figure 7. The metallography round sample B (the gray bottom is scale layer, the black middle is the interspace and the top is metallic style)

There are large numbers of black strip micro-flaws which distributing through crystal or indwelling the point of pearlite and ferrite in the metal style of the water cooling inner wall round the sample B as picture 7 showed, and there is no eroded offspring in the inner flaw. Mostly of the scale layers are separated from the body, little joints the body. It is clearly that the hydrogenous eroded flaw in the 600 times (dip in 4% nitric acid alcohol) metallography of the picture 8.

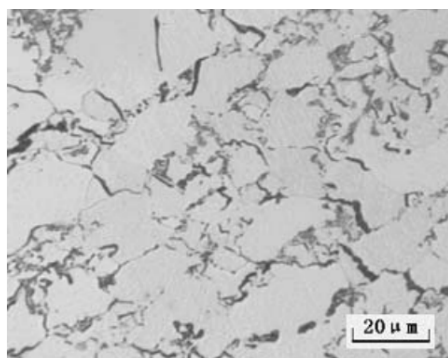
Figure 8. The 600 times (dip in 4% nitric acid alcohol) metallography of sample B
